# KAMLOOPS REGION

## WAYSIDE

**Property name:** WAYSIDE

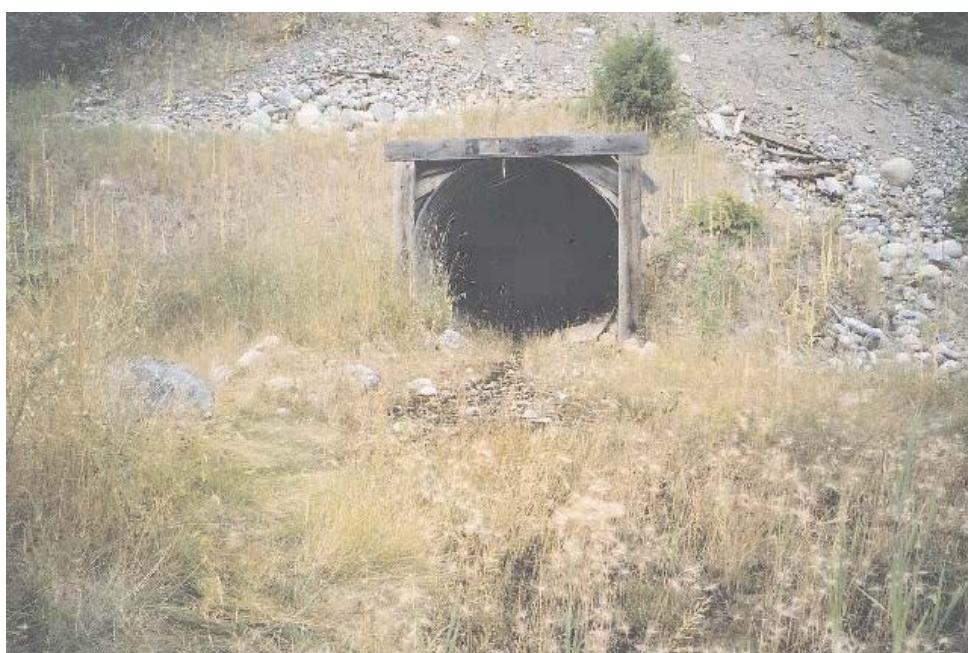
The No. 5 adit is the lowest, most southerly adit of the Wayside workings. The adit was inaccessible as it was gated and locked. The drainage flowing from the adit was sampled.

Photo 15. Wayside adit.

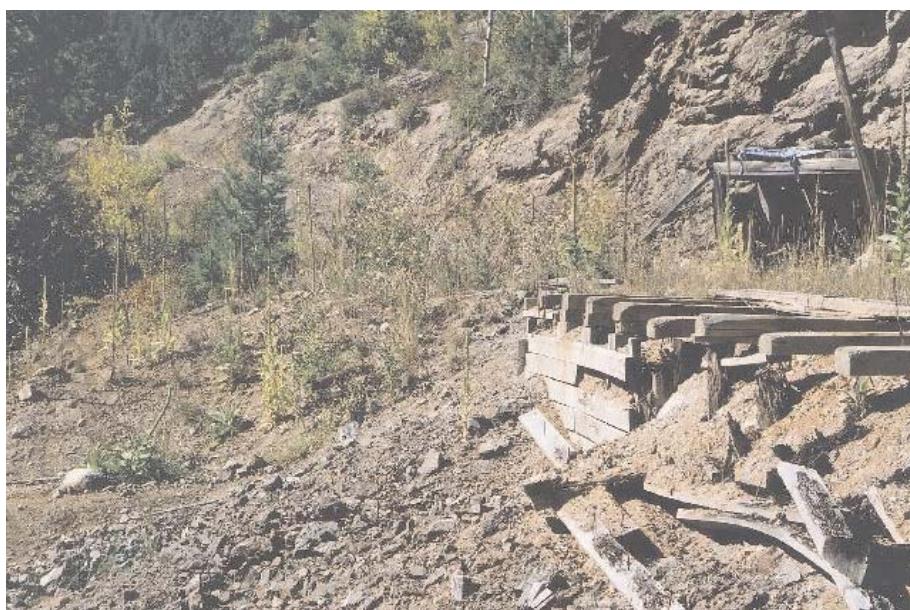
The drainage from the lower portal was diverted under the access road and flowed from a pipe on the other side. From the pipe the water drained down the waste rock dump, into the surrounding forest.

The flow from the lower portal was 1 L/min. Oxidation of rocks in the path of the drainage is moderate and a red-brown colour. The field pH = 7.0-7.5 and conductivity = 830 s. No salts were observed and the water was odourless. Water was sampled directly from the pipe.

Photo 16. Congress adit (background). The drainage from the adit is draining from a small pipe, located below the tracks.

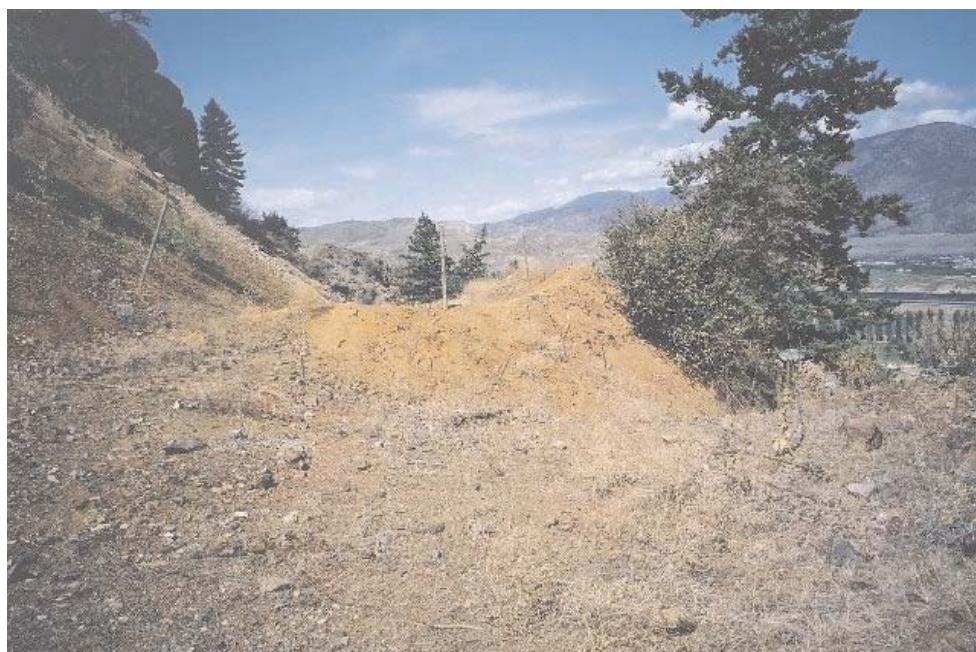
At the base of the mountain there is an oxidized waste rock pile. The dump is strongly and pervasively oxidized to a red-orange colour to an approximate depth of 2 cm. The oxidized waste is mostly comprised of fines. The volume of the oxidized dump is in the order of 500 m<sup>3</sup>. The dump was very dry, making the fine

fraction easily transportable by wind. The dump has a very strong sulphur odour.

Hikers frequent this area. Thus, a principle concern is the hazards to human health and safety related to the mine workings. The use of the heavily oxidized dump material as a fill material in the housing development and the mobility of the oxidized dump fine fraction are environmental concerns.

Photo 17. Oxidized waste dump at Dividend-Lakeview.

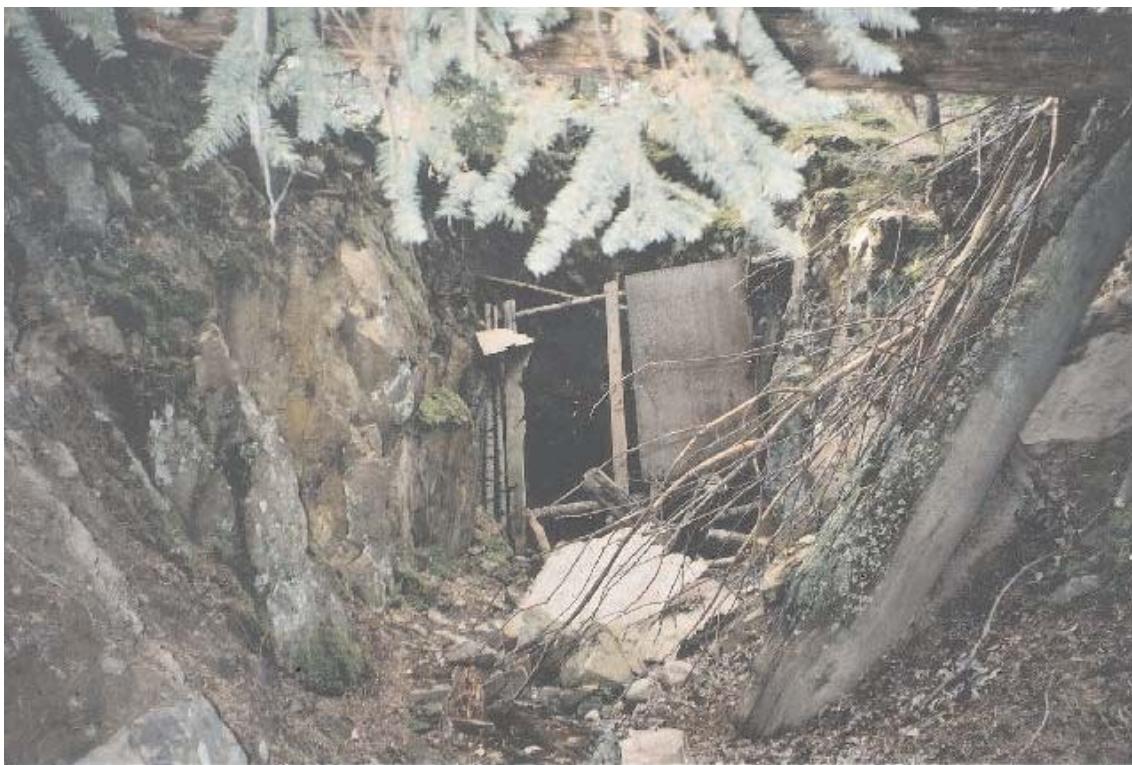
Adit No. 2, the lower adit, has decaying boards unsuccessfully barring access. No water was draining from the adit. There were no traces of spring runoff, e.g. salts, precipitates, flow path.

Photo 18. Snowflake adit.

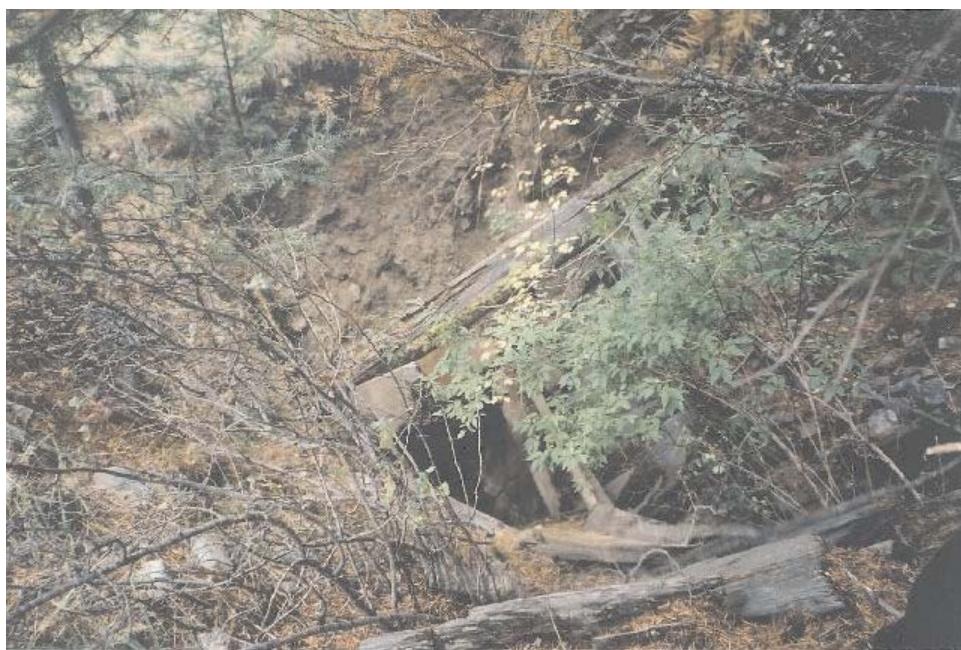
Photo 19. Open, flooded shaft near the glory hole at Twin Lakes.

The decline shaft is partially covered by a caved wooden structure. The shaft was flooded. Access to the shaft is possible.

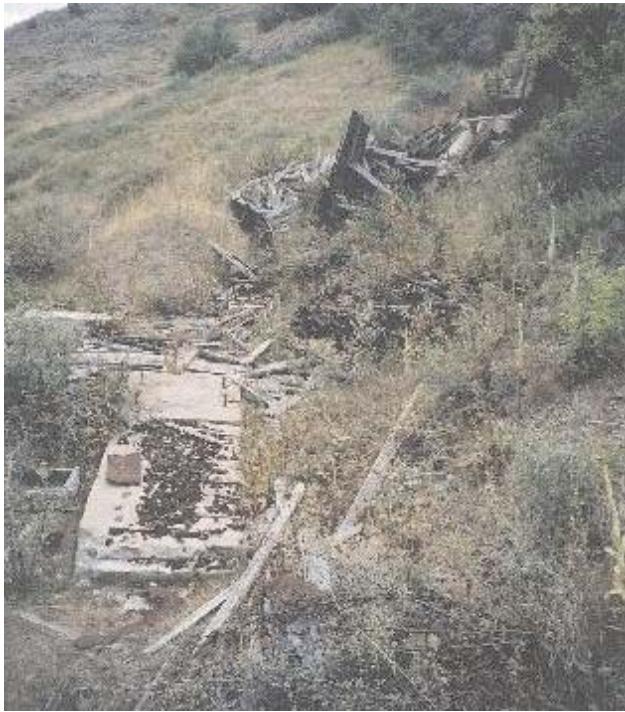
The old mill is located north of the access road. Remains include old concrete foundations, scrap metal and wood as well as a collapsed wooden structure.

Photo 20. Twin Lakes mill.

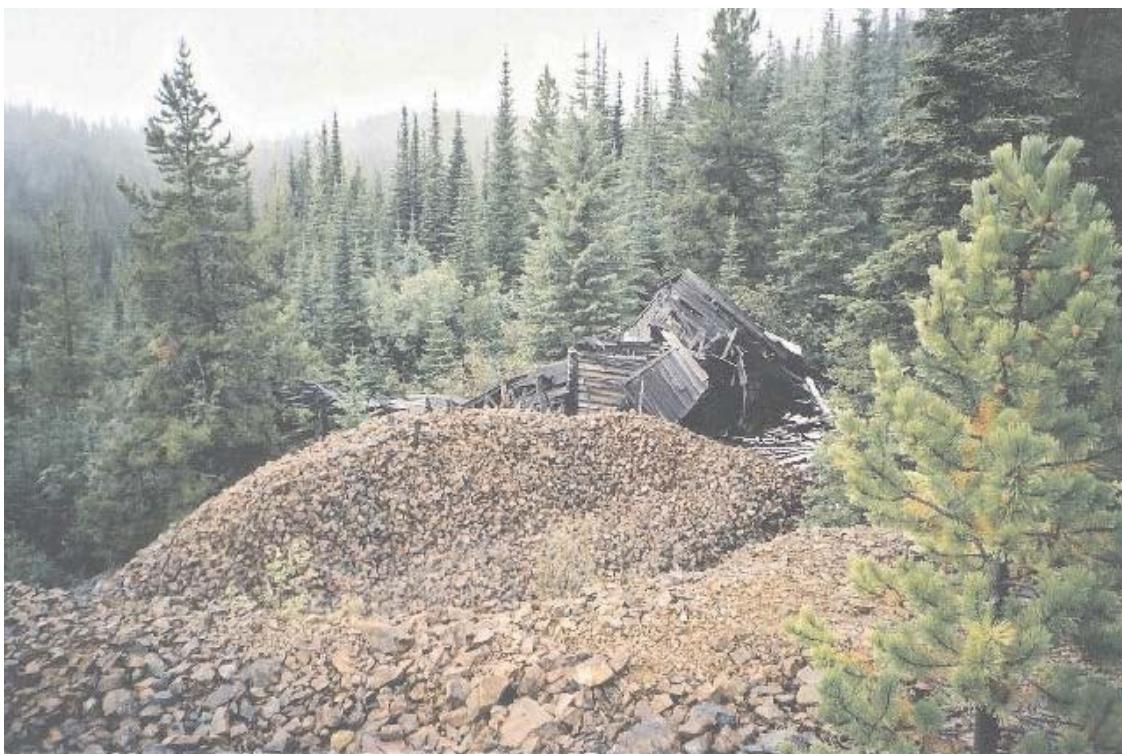
Photo 21. Sweethome dump and decaying wooden structure (tram?).

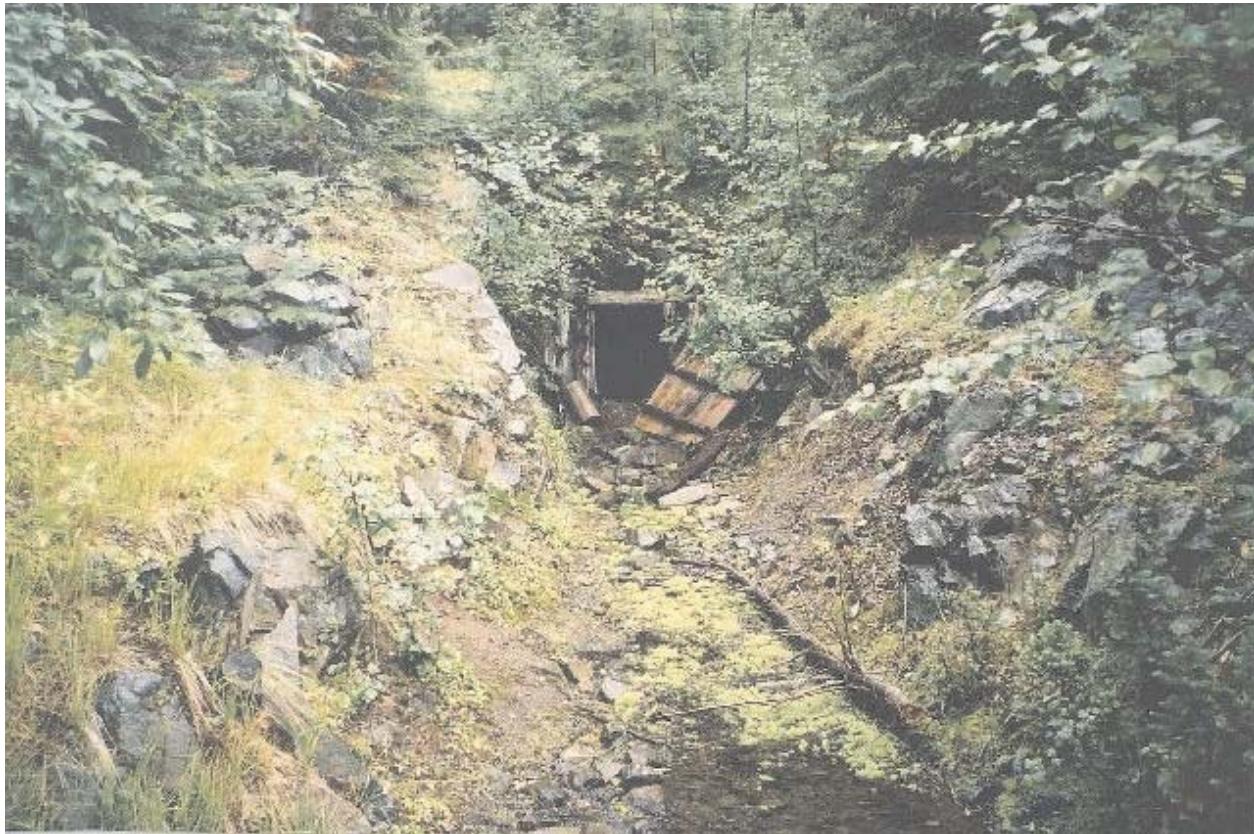
Photo 22. Windpass portal and drainage.

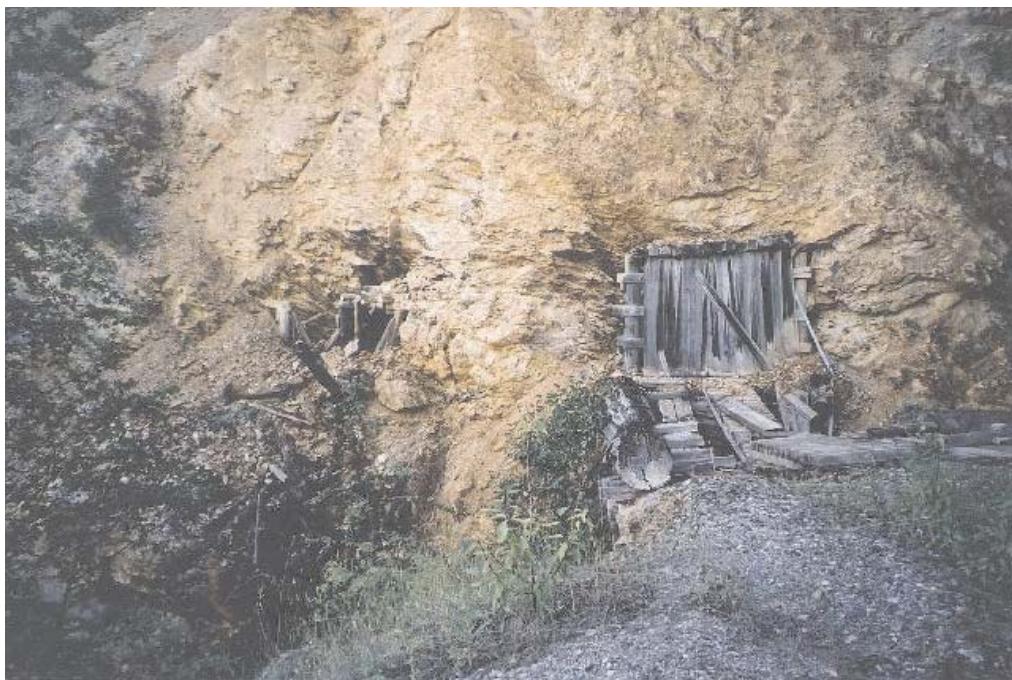
The Homestake adit has 2 openings: the main portal, which is timbered with a wooden door, and another small, timbered portal, which is accessible. A rotting, unstable wooden bridge crossing Homestake Creek

Photo 23. Homestake (Kamad) partially flooded upper adit. Homestake Creek flows beneath the bridge leading to the portal.

to the main portal remains. The adit is dammed and partially flooded with stagnant water. The water was draining from the adit and sampled.

The stagnant water dammed in the Homestake adit has a sludge on the surface and is laden with Fe-precipitates. The depth of the water could not be determined. Runoff from the portal is low, about 10 L/min. The water was draining from the downstream corner of the portal only. The downstream rocks were heavily stained red. The pH of the drainage = 3.5. Both above and below the portal, the pH of the stream was 5.5. The drainage smelled strongly of iron.

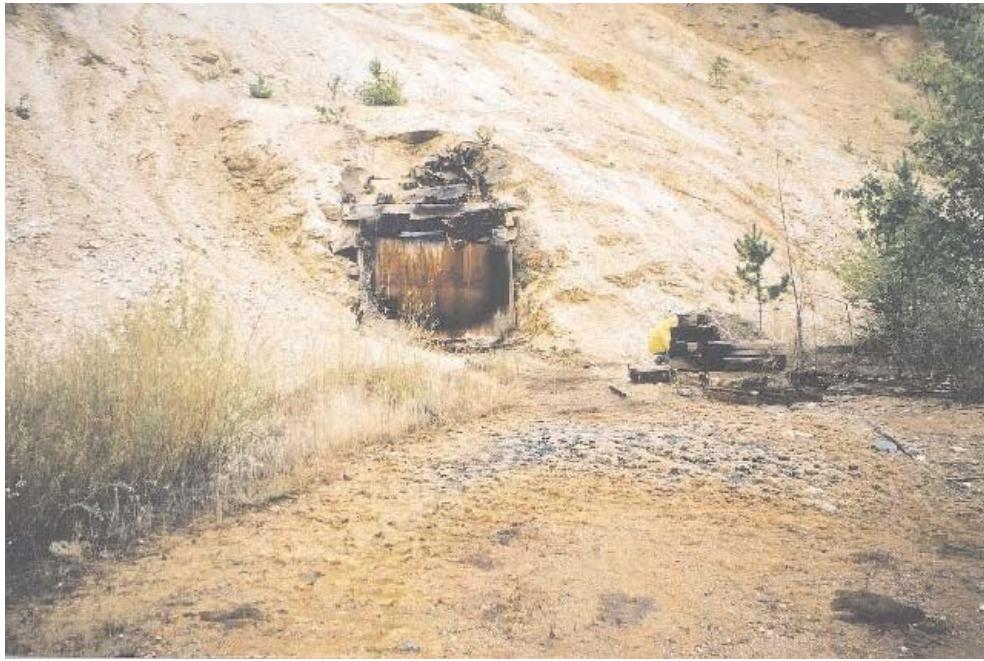
The lower portal is located west of the Homestake Creek adit. The phyllitic rocks around the portal are failing. A wooden door blocks access to the adit. The adit is flooded and water is draining from the portal. The water was sampled.

The waste rock dump is about 50 m in length and slopes at ~40 degree angle. The surface weathering of the dump is heterogeneous; the oxidation colours observed include red, yellow and dark red-brown. The degree of weathering also varies along the length of the dump. Disseminated pyrite (0.25 mm) is hosted in phyllite and schistose rocks. Iron weathering in the talc-schist appears to be the primary source of oxidation. A crust 15 cm deep covers the surface of the dump. The depth of oxidation is about 8 cm. Grasses & trees are vegetating the top and the base of the dump. The dump face is too steep to host vegetation. There are silty, saturated orange iron precipitates deposited at the toe of the dump. No direct source of the precipitates was observed.

Photo 24. Homestake (Kamad) lower adit. Note white salts in front of the adit.

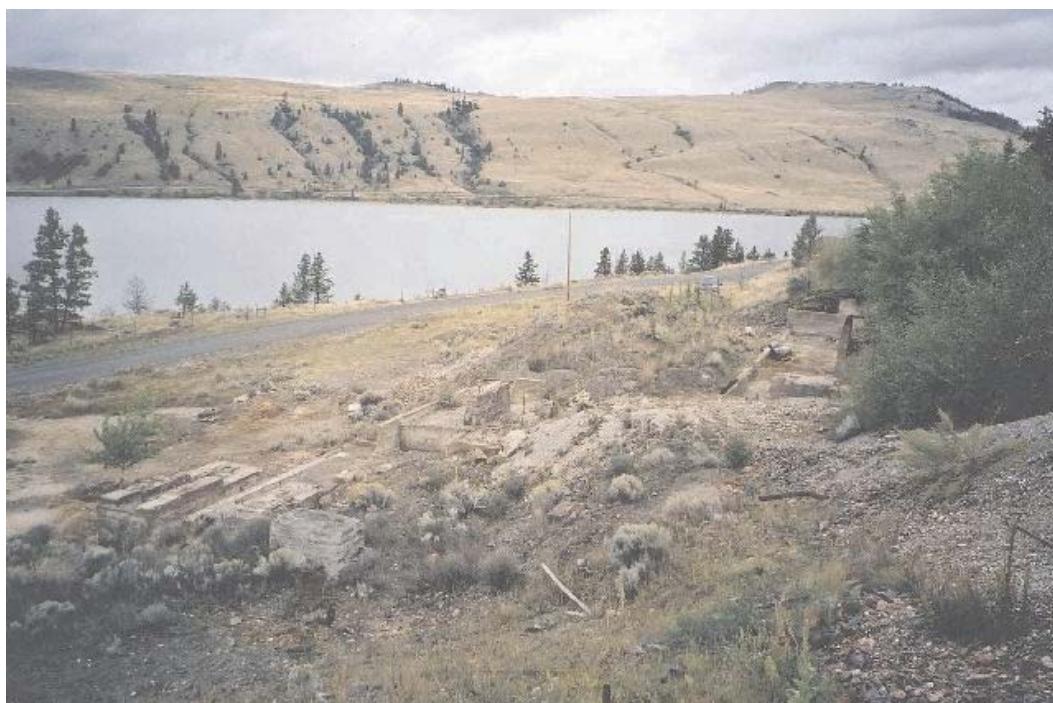
Concrete mill foundations remain. No equipment was noted. About 15,000 m<sup>3</sup> of processed ore is at the mill site. The ore is strongly oxidized to an orange colour with trace amounts of malachite.

Photo 25. Enterprise mill foundations.

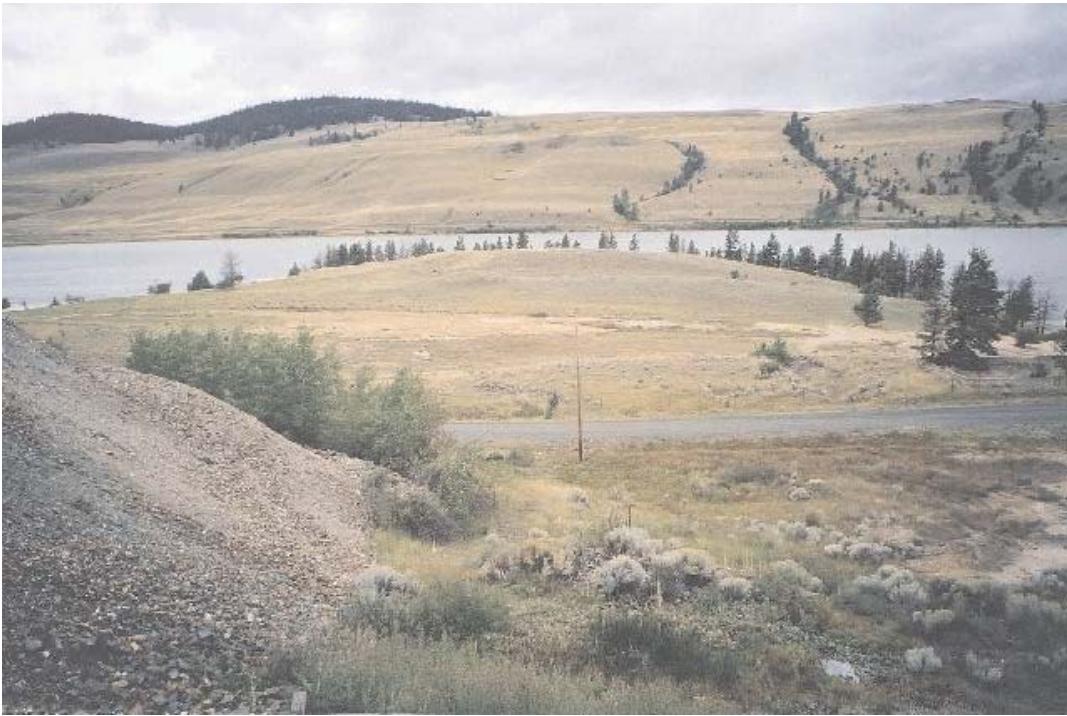
Photo 26. The partially revegetated Enterprise tailings facility (across the road). Dump is in foreground.

The tailings on the west side of the road are located on private property. At the time of the inspection, people were living on the tailings in motor homes and trailers. The tailings extend from the foot of the mill to the waters of Stump Lake. The tailings are oxidized to rust orange-brown, yellow green and blue-green colours. Malachite precipitation is present. The iron weathering of the tailings is inconsistent. The tailings at the foot of the mill and the western extent of the tailings are heavily oxidized on the surface to a bright orange colour. The northeast extent of the tailings is heavily oxidized in the subsurface to a bright orange-brown colour while the surface oxidation is very minor. The area of the tailings is in the order of 2,000 m<sup>2</sup> and the depth of the tailings on land is up to 2.5 m. Grasses and bushes grow on the tailings.
