LENORA

Property name: LENORA (L.35G)

Date: June 30, 2000 / November 23, 2000

Location: Mount Sicker

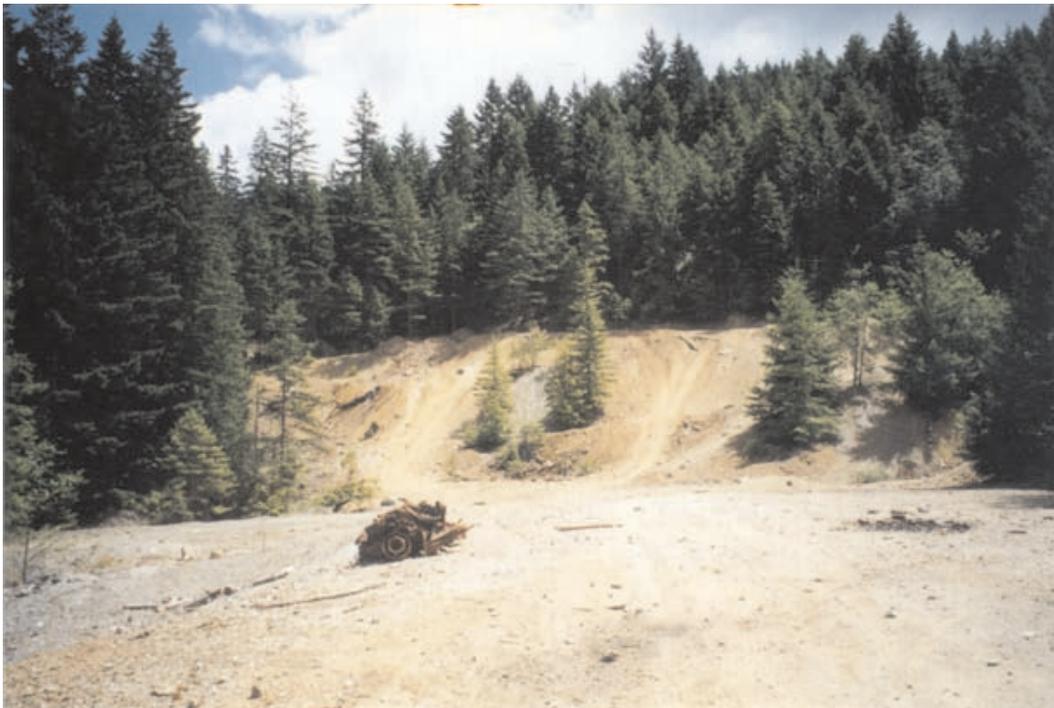
The waste rock dump trends SW-NE and is located on on the foot of a hill. It is primarily composed of fines and is heavily oxidized in patches to orange, red and brown. The volume of the dump is approximately 3,000 m³. The dump is used as a playground for motor bikes and mountain bikes(?). The seepage from the toe of the dump was sampled.

Main waste dump contains seeps at the toe. The seep was sampled.

June 30, 2000 - The dump was seeping at the southwest toe. The field pH = 5.1, the conductivity = 800 μ s and the sulphate = >200 ppm. The seep was sampled but not analyzed. Lichen was growing in the area of the seep. White precipitates/salts were also noted.

November 23, 2000 - A test pit was dug in at the southwest toe of the waste rock dump to collect seepage. Although seepage was present, water was flowing through the dump at a slower rate than in the summer (it took a few minutes to fill the pit). The pH=4.0. Green, red and brown lichen was growing in the seepage areas. The seep water was very turbid and odourless. The seep was sampled for further geochemical analyses.

The dump is ML/ARD. The high concentrations of metals may reflect the first fall rainfall event of the season, which may flush salts from the dump.

Photo 74. Lenora waste rock dump. The drainage flowing over the dump and seeps was sampled.

ML/ARD is a concern for the waste dump. The drainage flowing over the dump is high in dissolved Cu and Zn. The dump is seeping dissolved Al, Cd, Co, Cu, Mn and Zn. The drainage was sampled on the first heavy rainfall of the season.

Further studies warranted.

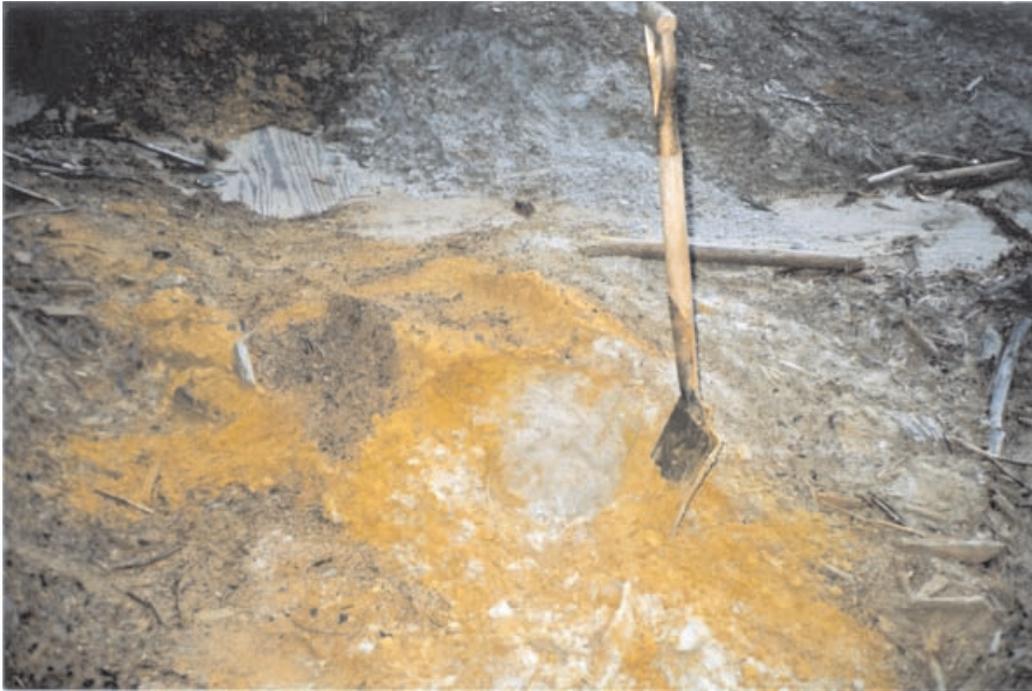
On the western extent of the road is the tailings pond. The area is ~240 m² with an estimated volume of 500 m³. The tailings are flanked by a clear cut forest block to the west. The tailings are very oxidized in patches to a bright orange colour. The tailings were sampled. A channel has been cut through the tailings by water, exposing the strata. The fate of the eroded tailings is likely out the spillway to lower elevations in the forest. The spillway is located on the western end and is clogged with wooden debris.

Photo 75. Oxidized subsurface of the Lenora tailings.

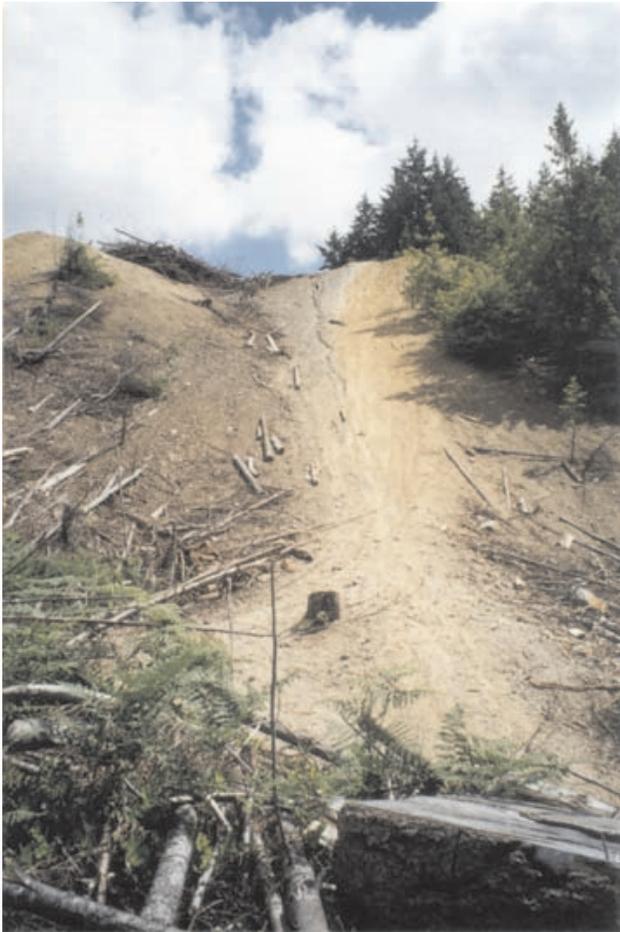
Photo 76. Tyee waste rock dump.

The two waste rock dumps are composed of waste rock and fines. The dump comprised of barite; schist containing disseminated chalcopyrite and calcite; and quartz with disseminate chalcopyrite. Secondary malachite and rusty red-brown oxidation are present. Immature trees are growing on the top and on the lower reaches of the slope. Scrap metal embedded in the dump.

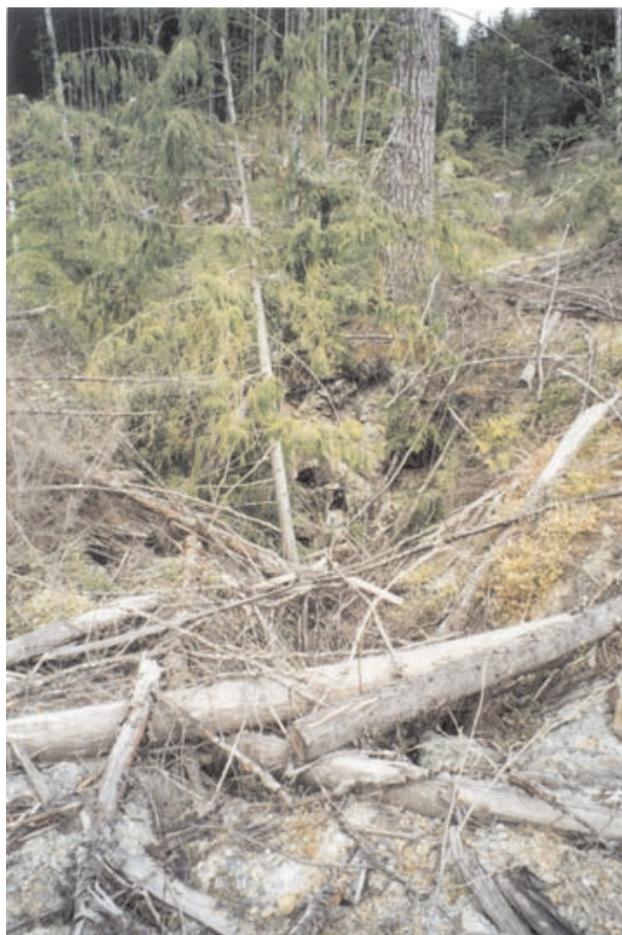
Photo 77. Richard III open shaft.

One collapsed and camouflaged shaft was located at the junction of 2 rough roads. The opening was partially fenced off but still accessible. Exploration drill holes are present in the vicinity. It could not be determined whether the shaft was flooded.

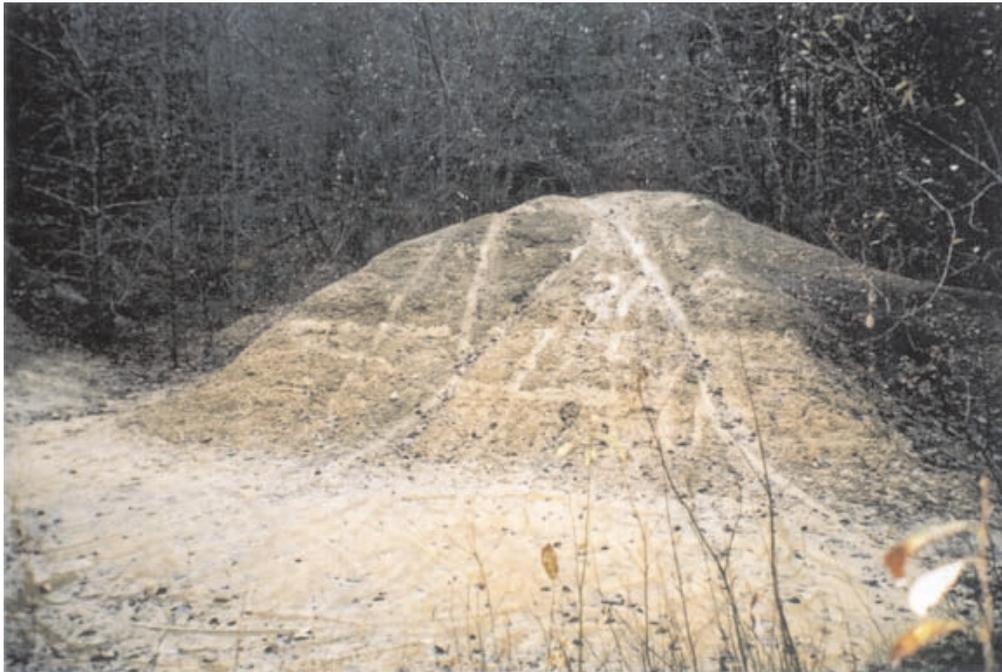
In the upper pond, preferential layering of the tailings causes drainage to flow toward the centre, the location of erosion and the source area for the lower ponds. The eroded gulley is approximately 1.5 m deep and is supporting juvenile trees in the vicinity. The tailings are pervasively oxidized to a red-brown colour containing minor malachite. Where water is pooling on the tailings, it is red. The area is used as a BMX bike course, particularly on the outside edges and in the eroded gulley. A sample of the tailings was taken. UTM coordinates of the upper tailings are: 410972, 5410778, elev'n: 349 m. The area of the tailings is approximately 100 m by 300 m.

Photo 78. Blue Grouse upper tailings facility.

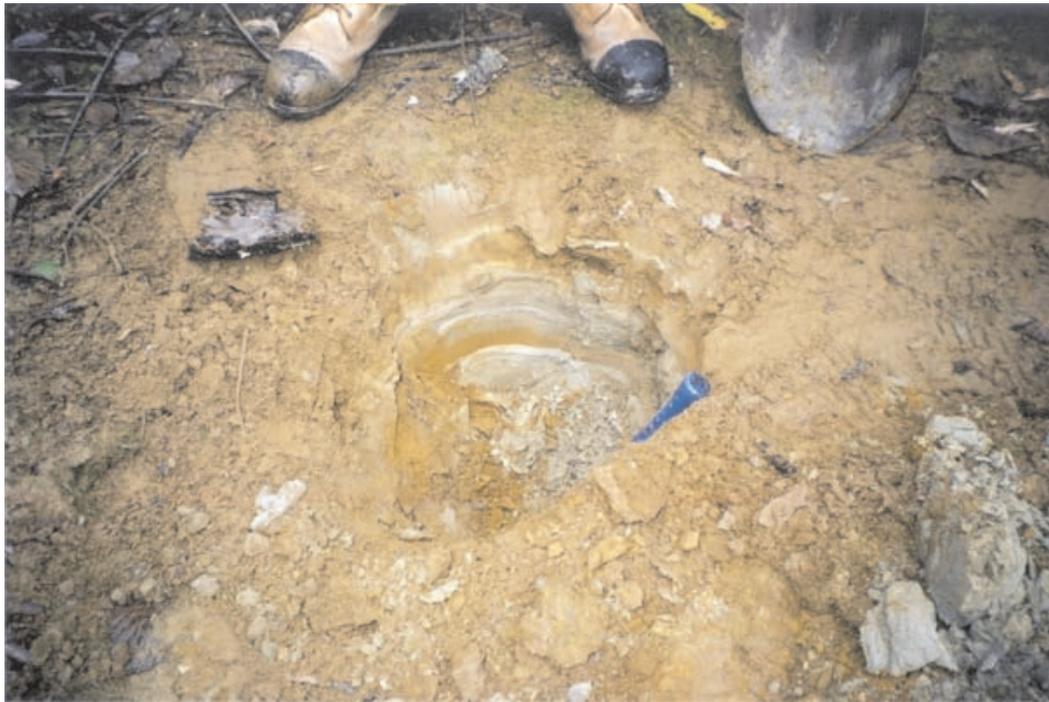
Photo 79. Blue Grouse upper tailings test pit.
