SMITHERS REGION

BIG ONION

Property name: BIG ONION
Map number (see Appendix C): 1
Mine drainage sample numbers: LB00 - 0101 to 0103
MINFILE number: 093L 124

Date: August 14, 2000

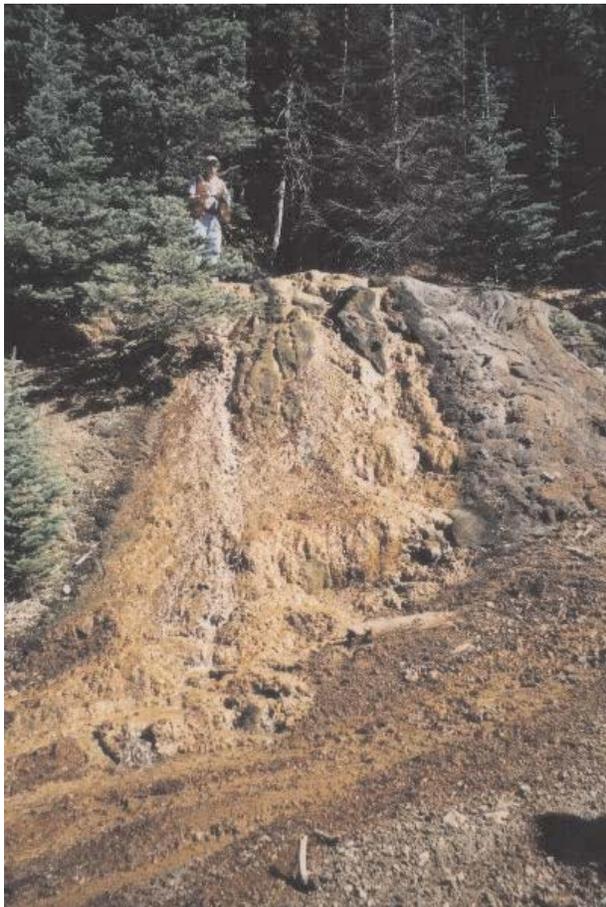
Photo 2. Drainage flowing from the Big Onion adits, located behind Bruce.

The water flowing from the 2 adits was draining at a net rate of approx. 80 L/min. The field pH = 4.5 and the conductivity = 430 μ S. The water had no discernible odour. White, green and red precipitates and salts

were observed. The Fe precipitates were prolific, depositing a clay-like substrate. The outcrop was covered in moss, the only vegetation within the flow of the water. The water was sampled.

- The drainage is acidic, as indicated by the field and lab pH values.
- Sulphate is in excess of the water quality guidelines, although it is relatively low given the low value of pH.

Metals in excess of the BC water quality guidelines for aquatic life include Al, Co, Cu, Fe and Mn.

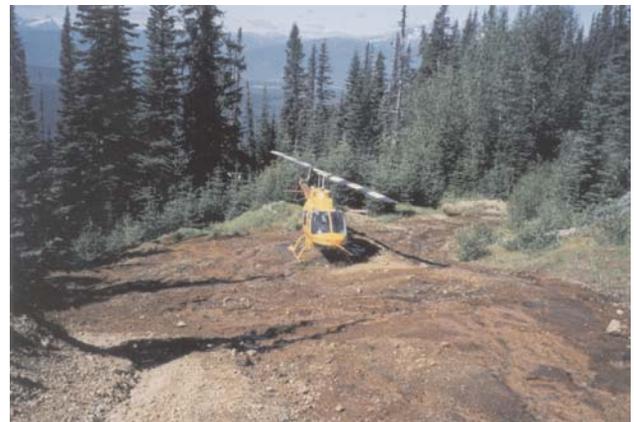
Photo 3. Downstream of the Big Onion adits

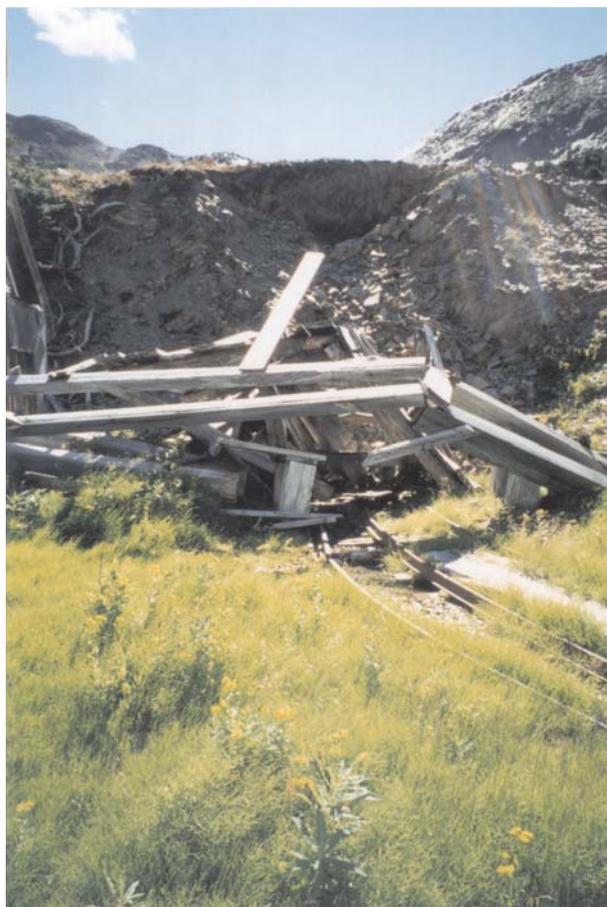
A collapsed adit with rail tracks is present. Slumped rocks, primarily phyllite and barite, barricade the portal. The wooden structure in front of the portal is collapsed. A trickle of water (~0.5 L/min) was flowing from the adit. The flow rate was so low samples were not taken.

Photo 4. Native (Lorraine) caved portal and waste rock dumps. Drainage flows from the adit.

The water draining from the portal had a field pH = 5.5. Conductivity wasn't measured as the water was too shallow. The water was odourless. No precipitates or salts were visible. Outside the portal was well vegetated with grasses.

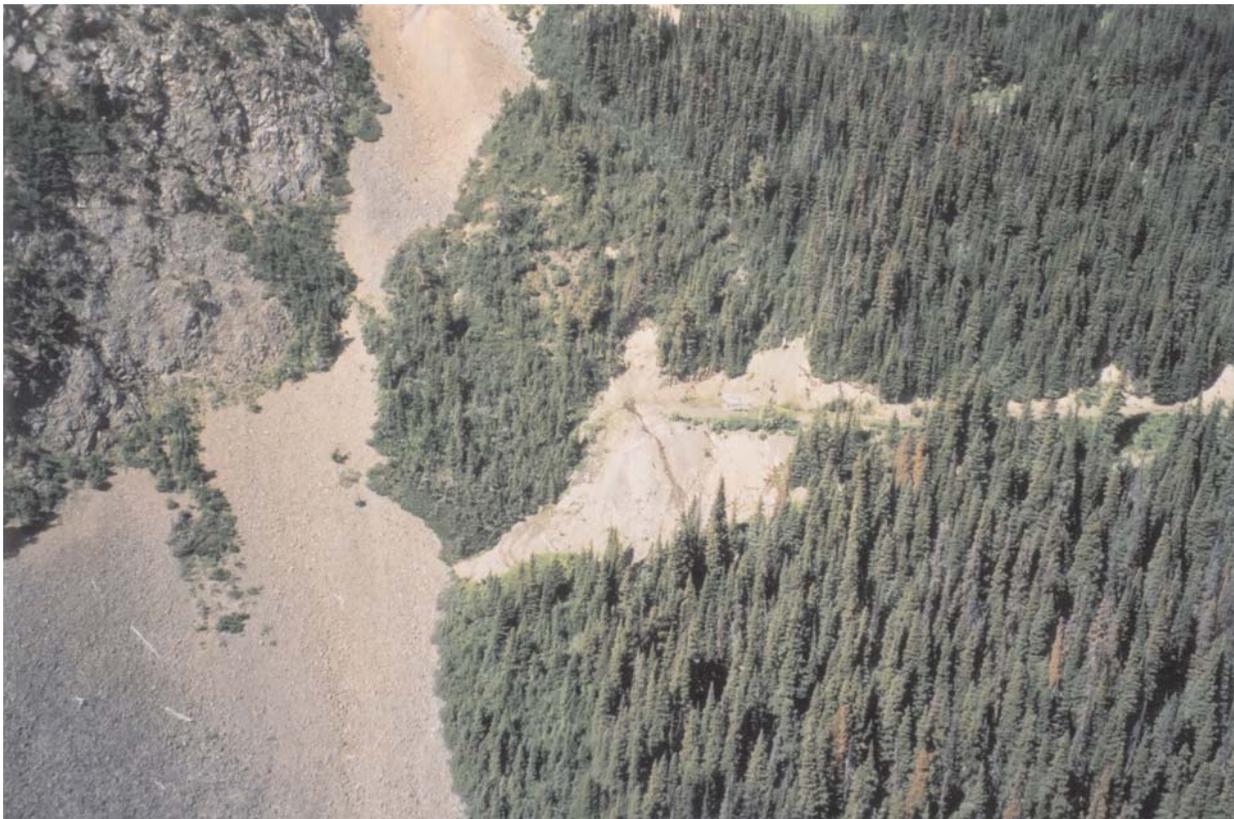
The lower adit (elev. 4720 feet) is backfilled with a small metal pipe to drain the adit water. Some drainage was flowing through the pipe, but most was seeping through the backfill material. The drainage was sampled. The adit is inaccessible.

Photo 5. Cronin lower portal. Note the adit drainage flowing over the dump.

The flow from the lower adit was ca. 40 L/min. Moss was growing in the vicinity of the water flow. The pH = 5.5 and the conductivity = 230 μ S. The water was odourless. Fe precipitates were observed but no salts were present.

Water quality results from the lower adit are: pH=7.37, [SO₄]=24 ppm and hardness = 191 ppm. Mn is the only metal in excess of the BC water quality guidelines for aquatic life.

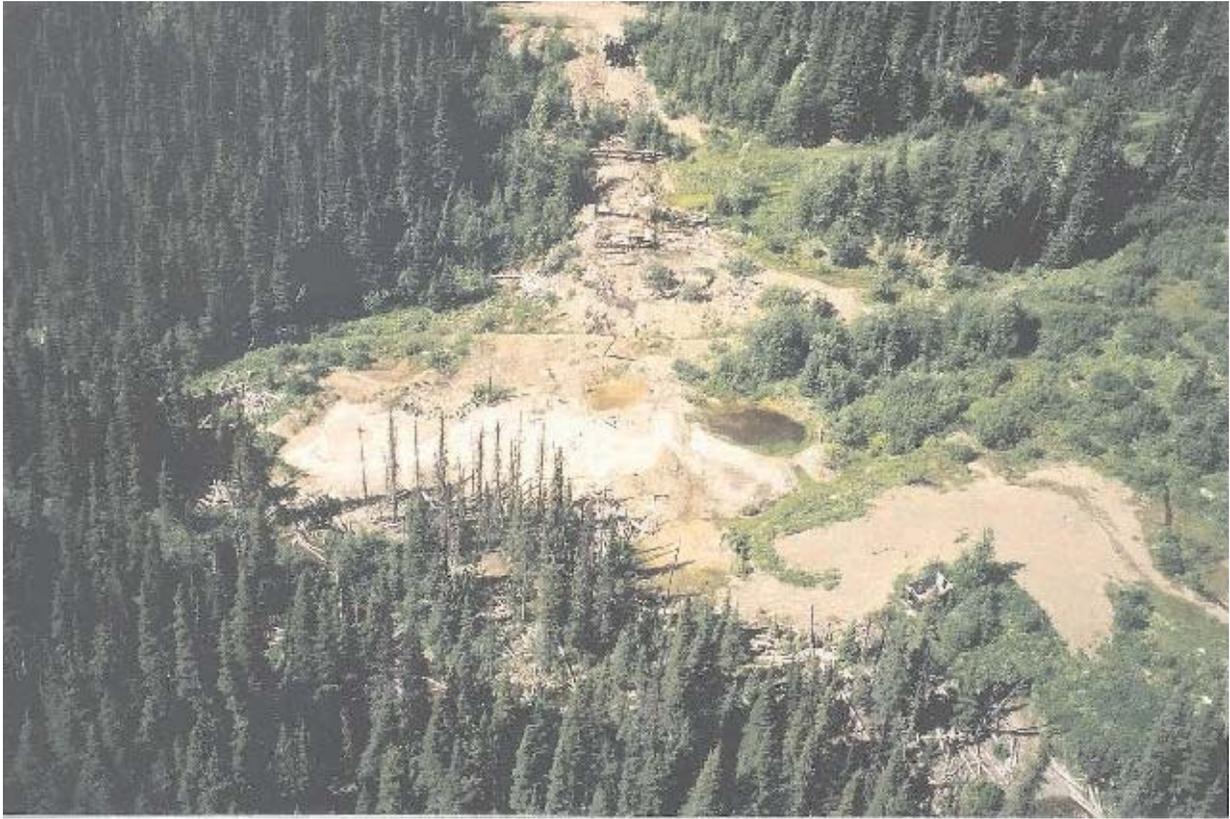
Photo 6. Cronin mill and tailings.

The tailings are situated at the foot of the mill in 3 impoundments alongside Cronin Creek. The tailings are sand sized and appeared unoxidized. There are 2 ponds present, both with horsetail. No seeps were observed. At the time of the inspection the constructed spillways contained white salts and/or thick moss. The area of the moss and salts extended beyond the spillways and into the areas of ephemeral drainage flow. The salts will dissolve and the metals will be transported when they next interact with water. Scrap wood is embedded in the tailings. A small, intact, wooden shack is adjacent to the tailings. Its stability is unknown.

A ditch is situated between the mill and the tailings. Seepage was draining from the foot of the mill site.

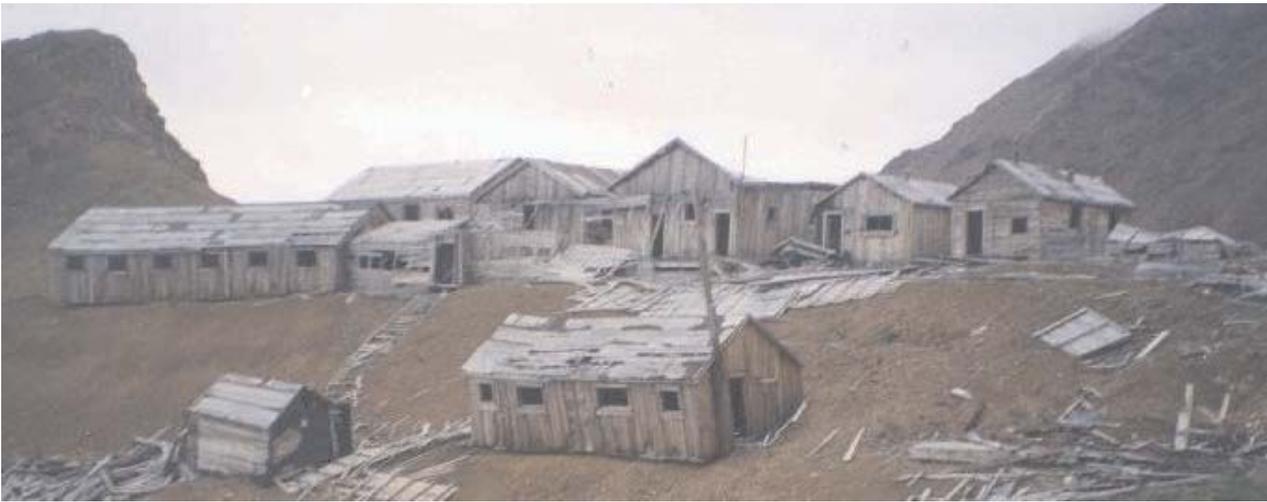
Numerous decaying wooden buildings are on site, including the former bunkhouses, assay lab, core shack, maintenance buildings and tram structures. No tram machinery was observed. Core, scrap metal and garbage were littered around the camp.

Photo 7. Upper camp of the Red Rose mine. The site is a favoured backcountry destination.

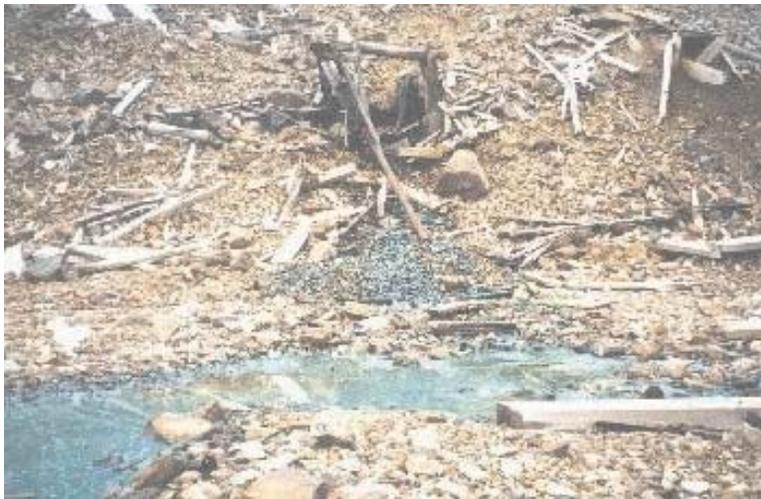
Turbid, odourless, blue water was flowing out of the 800 level portal at approximately 30 L/min. The field pH = 5.0, conductivity = 640 μ S and the temperature ~5C. Heavy malachite precipitation was evident in the drainage ponds outside of the portal. Deposition of the malachite was up to 15 cm deep. No vegetation was present in the alpine.

Elevated metals in excess of the BC water quality guidelines for aquatic life include Al, Co, Cu and Fe.

- Al is 1 order of magnitude higher than the water quality guidelines. The species of Al is colloidal/particulate.
- Co is 1 order of magnitude greater than the water quality guidelines. Co is dissolved in the drainage.
- Cu is 2 orders of magnitude above the water quality guidelines. Cu is both dissolved and colloidal/particulate. The particulate fraction is high as malachite was unavoidably sampled with the drainage.
- Dissolved Fe is below the water quality guidelines but the total concentration (dissolved + colloidal/particulate species) is of the same magnitude but above the threshold concentration. No precipitates were observed.

Photo 8. Drainage with malachite precipitate flowing from the 800 level portal, Red Rose mine.

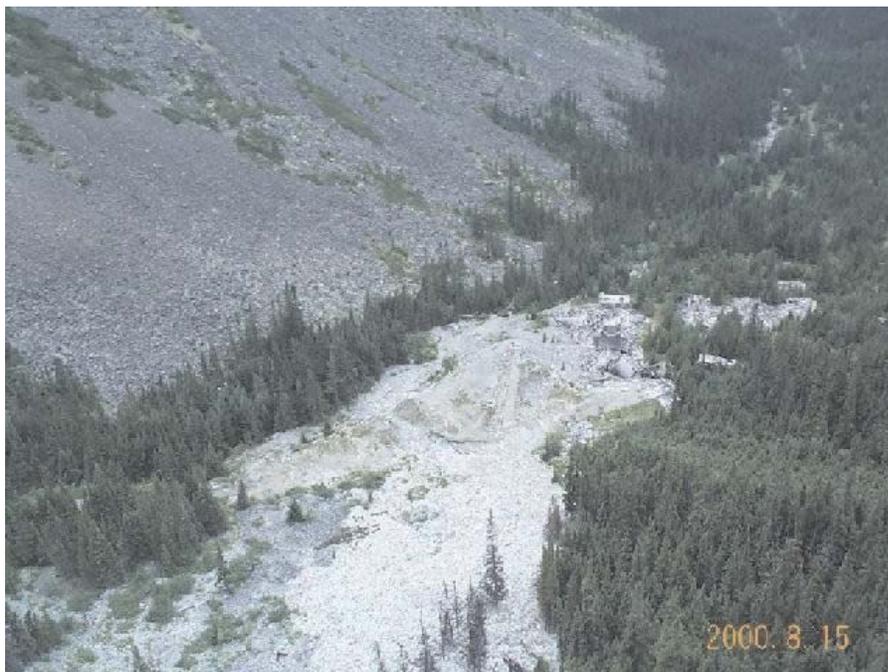
The mill site is located in the valley at an elevation of 4080 ft. The ore was brought to the mill site via the tram. The mill site is in a state of disrepair with numerous decaying, collapsed buildings that are potential health and safety risks. The wooden structure, possibly a load out station is still erect. Fine and coarse ore bins are on site but no ore piles were found. Wood debris, core and core boxes, concrete foundations and scrap metal (cars frames, bikes) noted on site.

Photo 9. Rocher Deboule mill site.

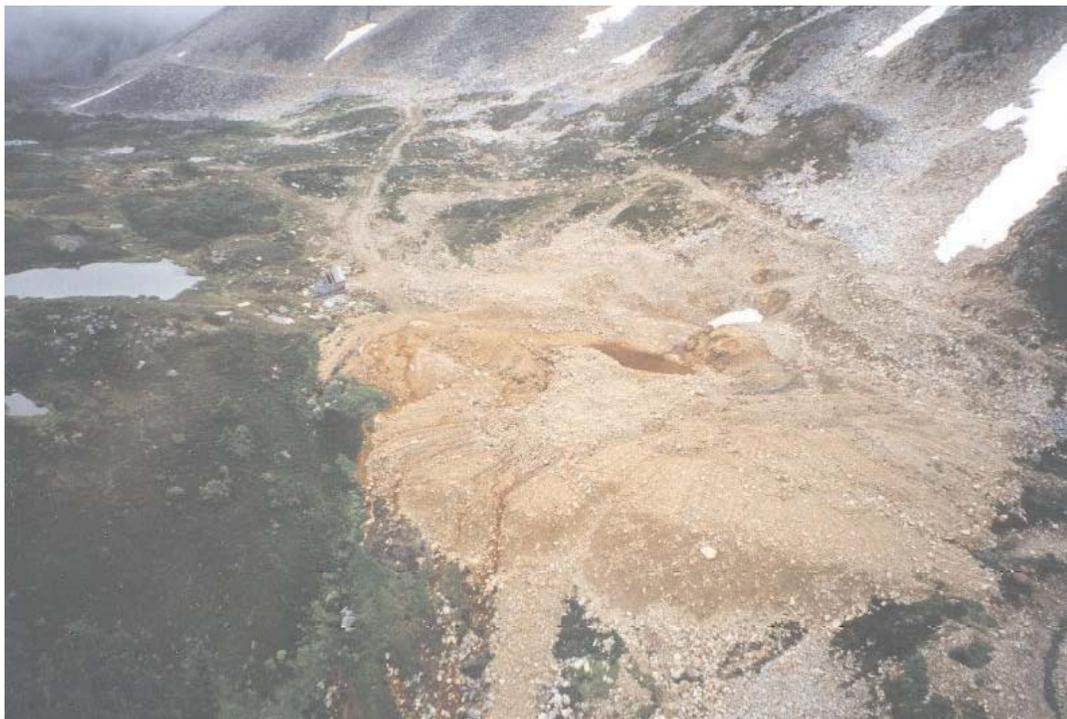
The portal was capped by snow. Red water was flowing from the adit. The drainage was sampled.

Photo 10. Area of disturbance at the Sultana mine site. The portal is located under the patch of snow. Note the drainage pooling and draining from the portal (dark red).

ity = 50 s, the smell of the water was slightly sulphurous and iron precipitate was concentrated heavily in the water, explaining the red, turbid nature of the drainage. The water from the adit flowed over the waste rock area and off site. Water samples were taken outside the portal.

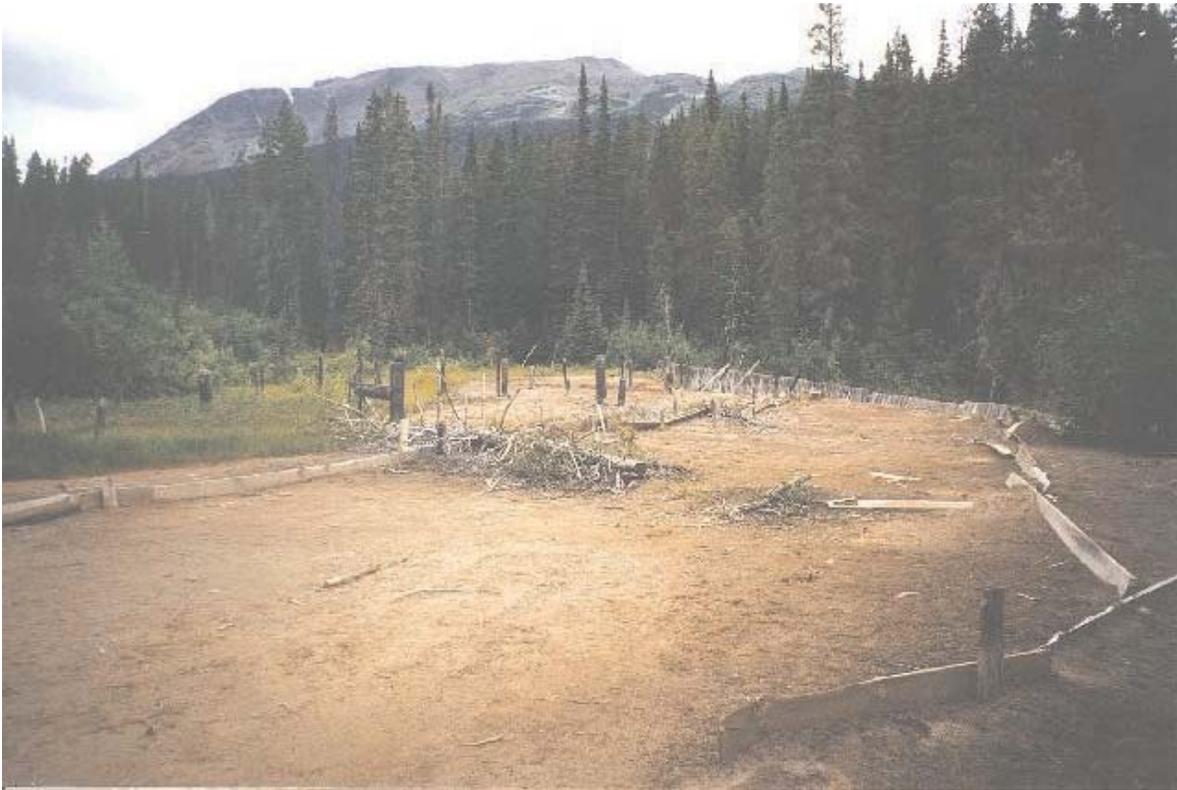
The northern tailings impoundment is about 100 m by 20 m by 0.1 m. The periphery of the tailings is vegetated with immature trees and red lichen. No seeps, signs of oxidation or salts were observed.

Photo 11. Emerald Glacier tailings. The workings are located on Mount Sweeney, located in the background.

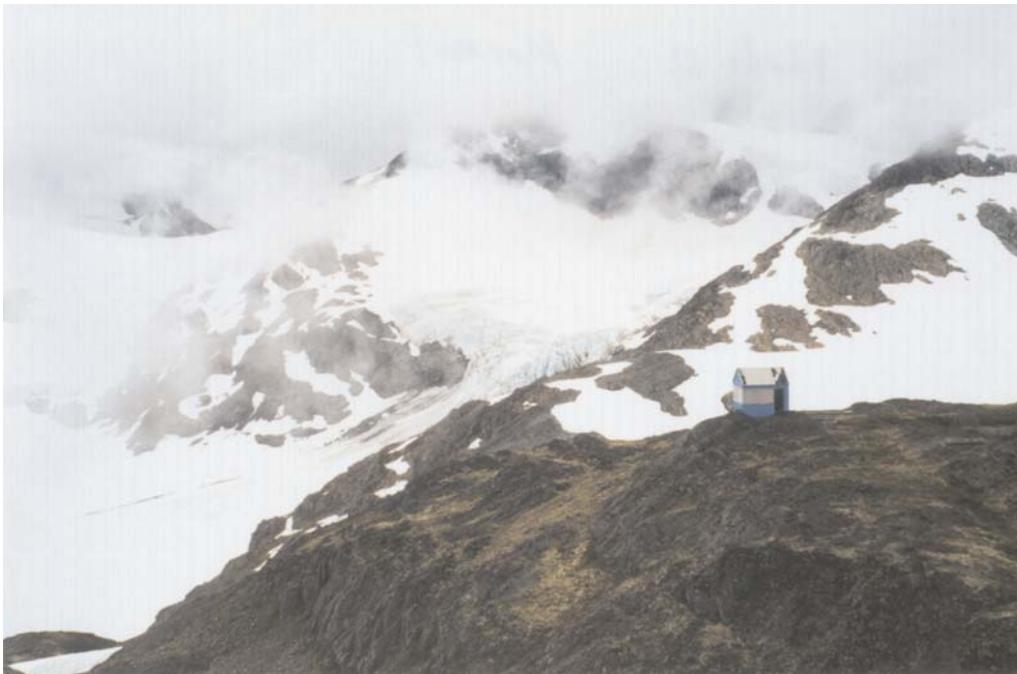
Photo 12. Marmot exploration camp.

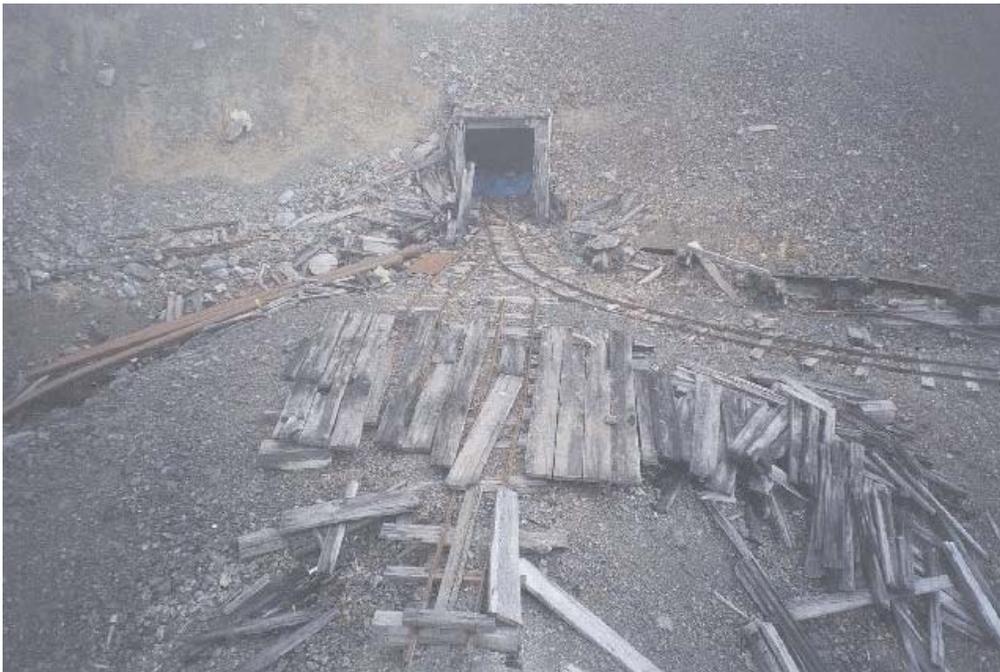
The 4700' portal is open and accessible. Rail tracks are coming from the timbered portal. The drainage flowing from the adit was sampled. Garbage was lying in the portal. Adjacent to the portal are numerous collapsed wooden buildings, barrels and rusting metal pipes.

Photo 13. Porter-Idaho portal (unknown level). The drainage flowing from the adit was sampled.

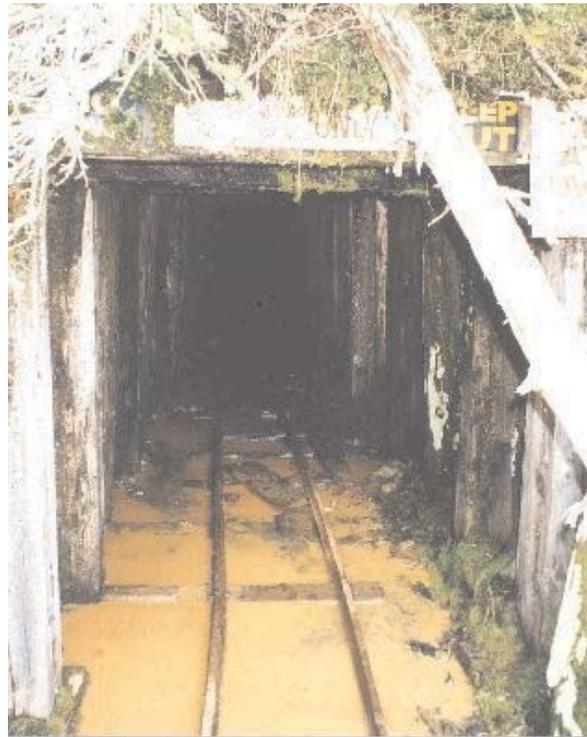
The drainage from the 1200' portal was turbid from the heavy iron precipitation. Sedimentation of the precipitates was up to 10 cm in places. The flow from the adit was about 20 L/min. Zinc precipitates were

Photo 14. Dunwell 1200' portal. The drainage was sampled.

also present but were less prolific than the iron precipitates. The water was sampled at the foot of the waste rock dump. The pH = 5.0 and conductivity = 380 μ S. The water was organic smelling. No vegetation was present proximal to the adit. At the foot of the waste rock dump shrubs and lichen were present.
